BELZONA REINFLATES FENDER

Dredging company, Abu Dhabi, U.A.E.

October 2013

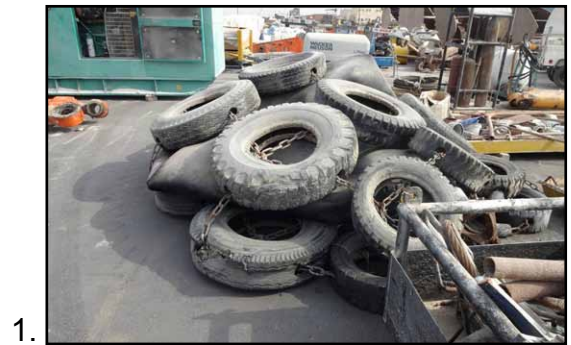
Although wrapped with tyres on chains to help protection, the fenders were in need of a full service or replacement. Punctures had deflated the fenders rendering them useless.

1. Initial inspection of deflated fender
2. Stitching of punctures
3. Application of Belzona 2111 incorporating
4. Reinforcement tape Finished application
