BELZONA REPAIRS NEW FLOATING HOSE SECTION DAMAGED IN TRANSIT

Oil company, North Sea, UK

November 2011

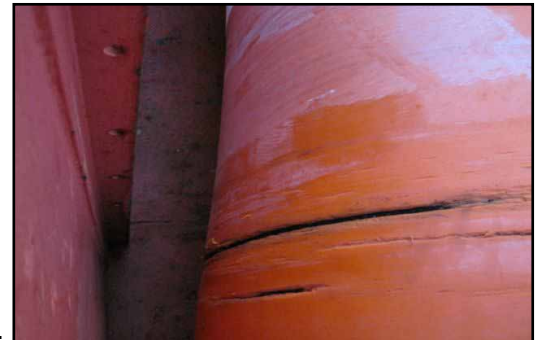
Hose had been damaged in transit as a result of its fastenings coming loose. The hose had rubbed against its container frame.

1. 15mm deep cuts in the floating hose cover
2. Application of reinforced system of Belzona 2211
3. Completed Belzona repair
4. Inspection of the hose 2 years later showing the Belzona application still in service

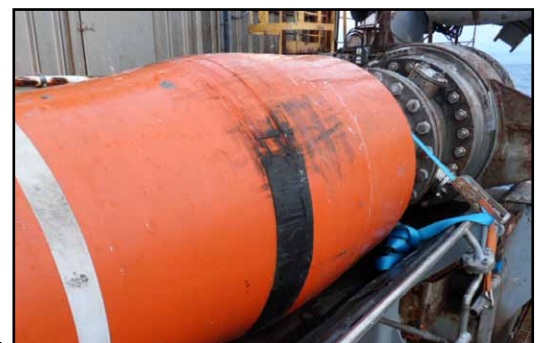
The application was completed at a fraction of the cost of a replacement hose and has proved to be successful for 2 years.
