CASE FILE

Rebuild of Flange Faces on DGF Vessel

Major Petrochemical Company, AUSTRALIA

Flange faces on the underside of Vessel DGF.

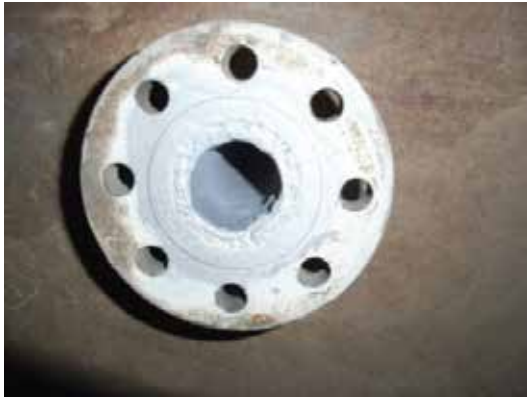
Blasting prior to application

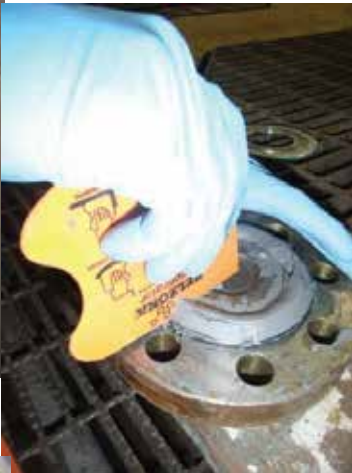
Belzona® 1111 Supermetal
being applied

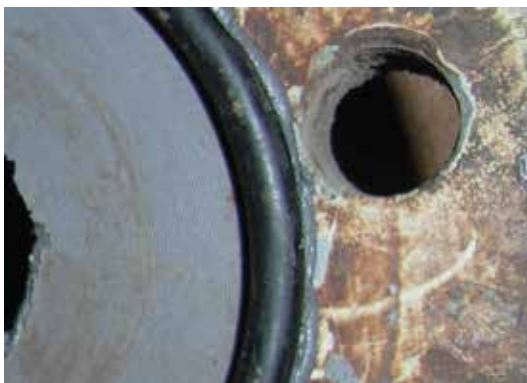
Completed application
(before O ring removed)
and edge cleaned up

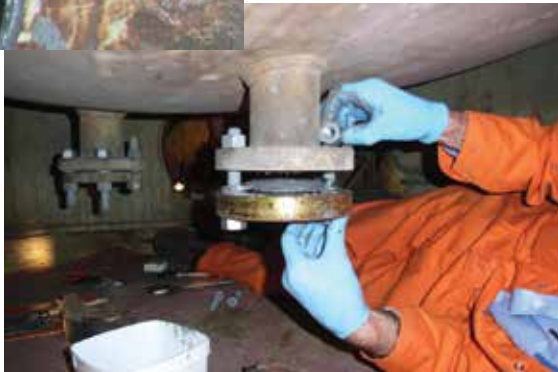
Blank being fitted
