CASE FILE

Keeping the lights burning with Belzona® 1831!

Power Station, Western Australia, AUSTRALIA

The leak repair was to the bushing of both the blue and red phases of the 330kV transformer.

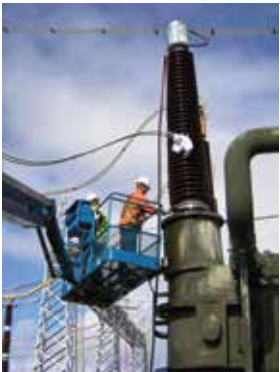
Cleaning the sealing surface

A vacuum was drawn on the unit to stem the leak by reducing the head pressure from the remaining oil. The substrates (steel/existing epoxy) were roughened using an electric MBX Bristle Blaster machine. Any excess oil was wiped away using acetone. The surface was first 'wet-out' by applying the 1831 with a short bristled brush. The 9341 membrane was also 'wet-out' and placed over the leaking area. Additional 1831 was finally applied over the top of the membrane and smoothed off. This was allowed to cure prior to removing the vacuum or filling with oil. The repair was carried out in accordance with TCC-01 and the relevant IFU's.

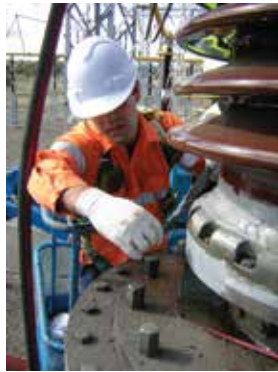
Applying the impregnated terylene strip

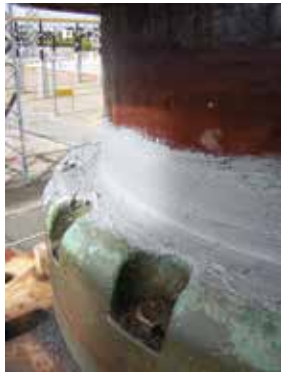
Finished profile

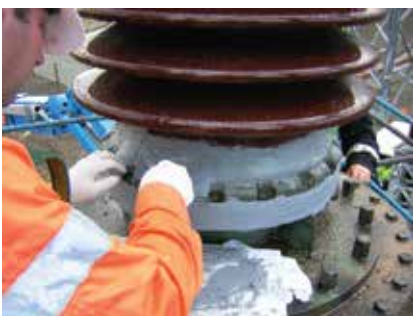
Brushing over the impregnated terylene strip

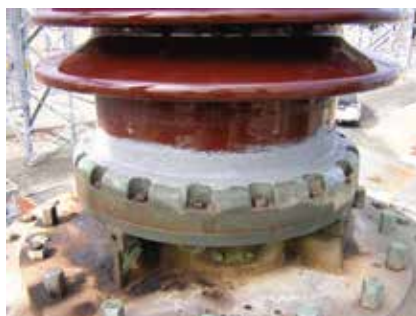
Finished overall profile
