BELZONA SEALS CANOPY ROOF

Bus Station, Lancashire, UK

Old canopy roof which was to form part of a new bus station.

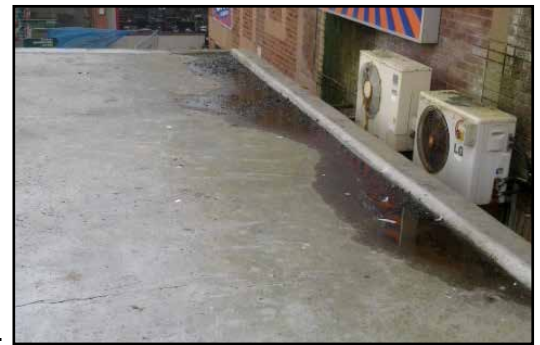
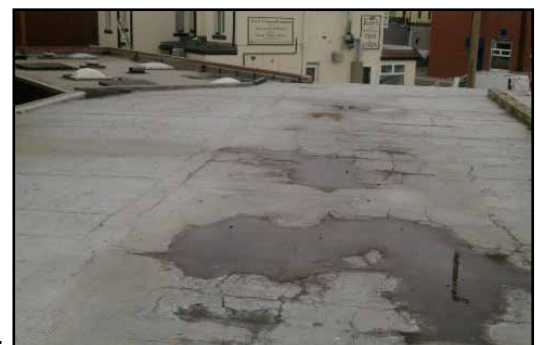
Asphalt roof covered with solar reflective paint had deteriorated due to coastal winds, sea spray and UV light over a number of years. The roof was now leaking. Customer needed roof to be fully waterproof especially as this was to be part of a new bus station.

1. & 2 General views of the roof before work commenced
3. & 4 Completed roof showing seamless finish achieved

Application was carried out in accordance with Belzona System Leaflet RPA-6. A simple pull-off test was done to determine which conditioner was best for the weathered solar reflective paint. This proved to be Belzona 3911 (PSC Conditioner). Roof was power washed and Belzona 3911 applied. Two coats of Belzona 3111 were applied with Reinforcing sheet. The result was fully sealed waterproof roof with a seamless finish.
