## BELZONA SOLUTION FOR LEAKING BALCONY

Church property, SW England

Concrete balconies

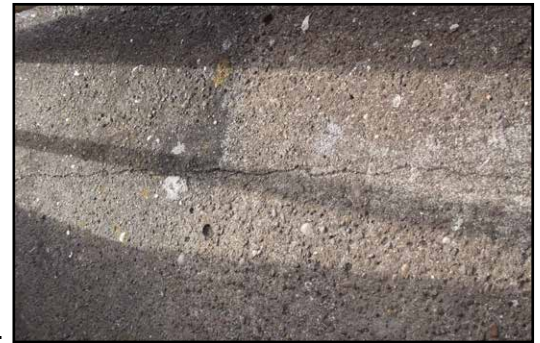
Over time the movement of the balcony had caused cracks in the substrate. The client had previously tried sand and cement repairs which had failed due to poor adhesion to the substrate. The client wanted a long term cost effective repair solution to these cracks and protection from future water ingress into the substrate.

1. Original condition of cracked balcony
2. Close up of crack after cleaning it out
3. Cracks repaired with Belzona 4131
4. Completed application coated with Belzona 5811
