BELZONA REBUILDS ERODED STERN TUBE SEALING FACE

Maersk Lines Container Ship, Lisnave ShipYard, Setubal, Portugal

Stern Tube of container ship.

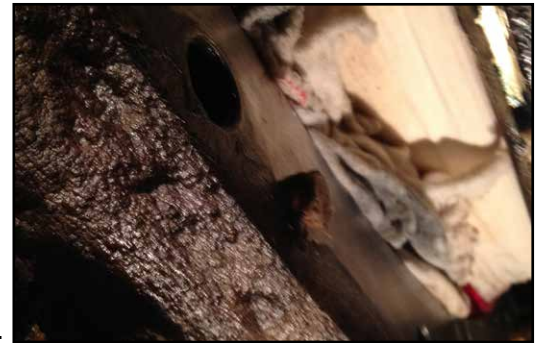
Galvanic corrosion damage on the boss sealing surface of stern tube system

1. Stern Tube with Galvanic Corrosion
2. Stern Tube after preparation with MBX Bristle Blaster
3. Stern Tube after applying Belzona 1311
4. Completed repair after polishing the Belzona 1311
