CASE FILE

“Fast Track” Refurbishment of a TKL1000x1200 Horizontal Shaft Split Case Pump

Melbourne Water, Victoria, AUSTRALIA

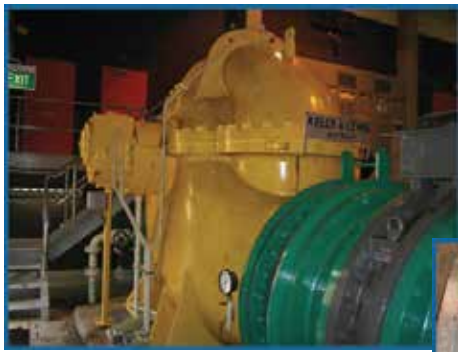
TKL split case
horizontal shaft pump

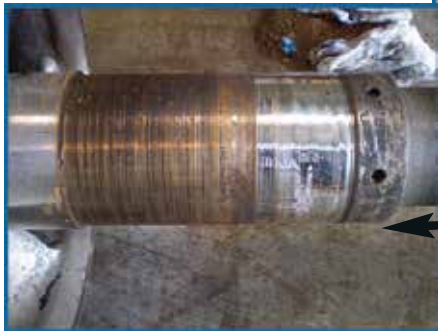
Rotating assembly showing worn
and eroded seal rings and shaft
sleeves

Rezitech's large centre lathes enabled the worn and eroded impellor seal rings to be machined off with ease. Rezitech then procured raw material to manufacture the replacement components from around Australia.

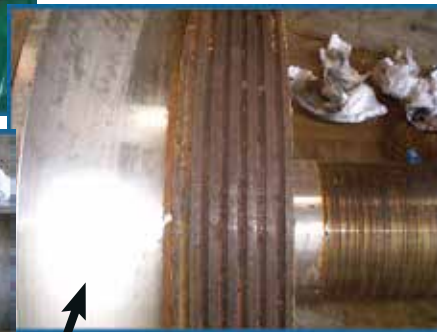
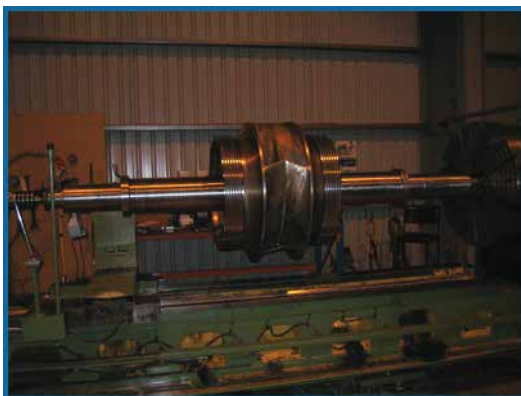
Refurbished assembly
with new sealing rings
and shaft sleeves

Rezitech's large machine job capabilities allowed replacement shaft sleeves as well as casing and impeller rings to be manufactured to spec in-house. Belzona® 1341 Supermetalgilde was also used for spot repairs on the pump casing damaged coating.
