CASE FILE

SET AND FORGET!
Repaired in 1995...
Still Perfect in 2008!!!

A Major Power Station, Gippsland, Victoria, AUSTRALIA

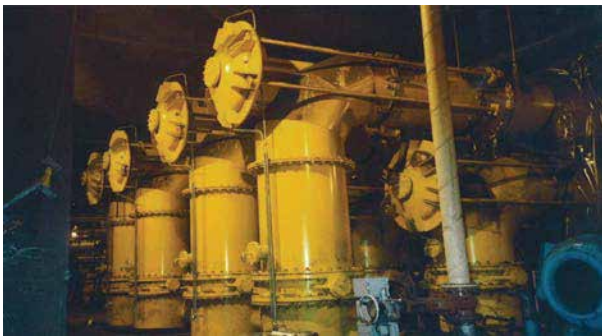
Water boxes and pipes in the power station's cooling water system were pitted and in need of repair.

Cooling water pipes

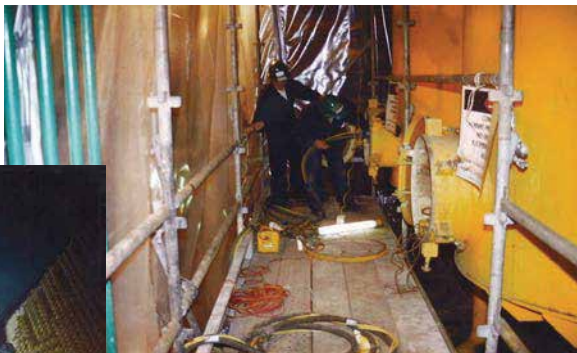
Water boxes

Repeated failures of existing coatings caused corrosion damage to the water boxes and pipes.

An inspection of the water boxes by the power station in May 2008 revealed a still perfect finish!!

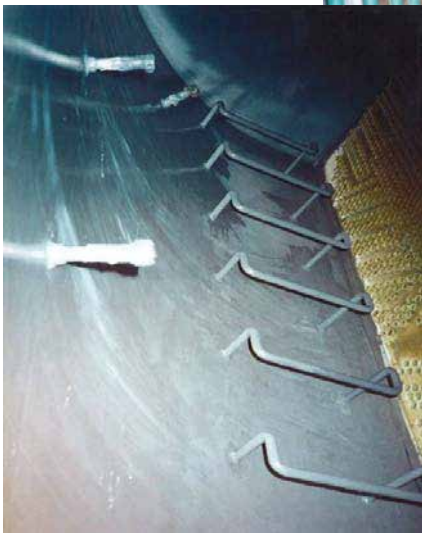
Belzona® 1341 applied

Rezitech performed the repair during the plant's scheduled shut down, in accordance with Belzona® Know How HEX-3.
