## CASE FILE

### Shaft Repair at Lead Smelter

Mount Isa Mine, Mount Isa, Queensland, AUSTRALIA

Damaged Shaft on Ducon Fan Blower

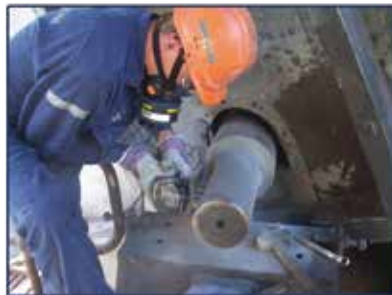
...grinding out the score on the shaft

The bearing had seized on this fan blower, which is used to extract lead dust from the blast furnace to the main stacks at the smelter, resulting in this damaged 150mm shaft.

The application consisted of grinding out the score on the shaft, followed by grit blasting to 75 micron with a 45 angular grit. A former was made up and used, made up in accordance with Belzona Know-How System Leaflet MPT-2.

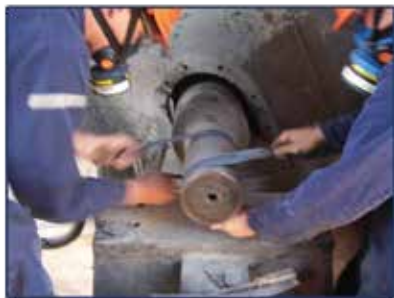
After building up the shaft with Belzona 1111, the former is removed, and the excess Belzona ground off

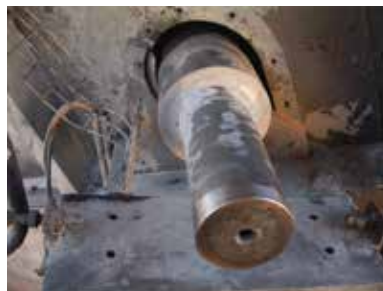
A Perfect Finish!  
And ready for work again by the end of the shutdown!

The plant only had a 48 hour shutdown period, in which the repair had to be done.

This was easily achieved in situ with significant savings to the plant, who would have otherwise incurred increased down time and huge costs.
