CASE FILE

Tank Support at Petrol Refinery

Major Petro-Chemical Refinery in Geelong, Victoria, Australia

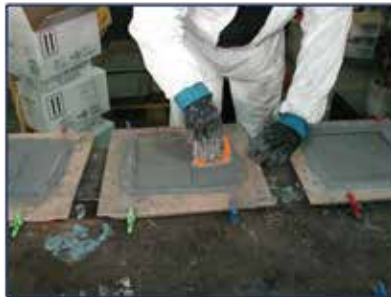
Belzona 1111 Applied

Metal plates 300 x 300mm x 10mm thick were fabricated. Followed by grit blasting on one side. A 6mm thick plywood frame was made with 50mm wide edge and inside edge coated with Belzona release agent, which was then placed over the plates to provide correct film thickness for the Belzona. Belzona 1111 was then mixed and applied onto the plates to the level of plywood former. Following overnight cure the plates were then placed into position under the tank roof supports and welded in position. When all 80 plates were fitted the total floor area was coated with a competitive product up to and over the plates to the edge of the Belzona 1111.

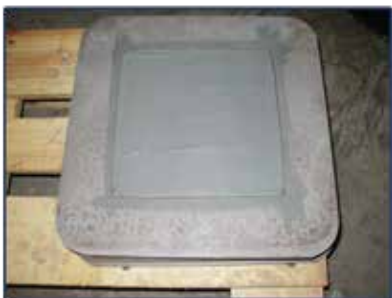
Completed Application

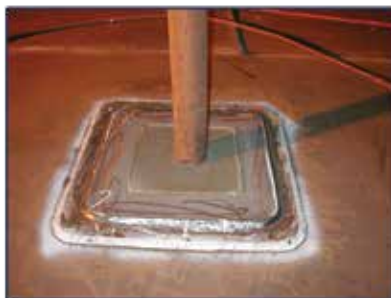
Pad in Position

Belzona provided a non corroding pad which would take the impact of the support legs but not damage the floor coating.
