CASE FILE

A Perfect Shaft Rebuild! Repaired Using a Former

A Large Paper Mill, Tasmania, AUSTRALIA

Dryer Journal Repair at a large Paper Mill

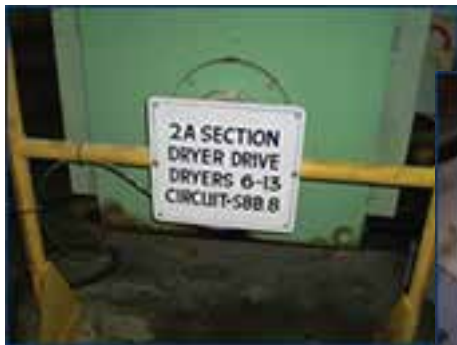
Location of Shaft to be Repaired

This damaged shaft in the dryer journal threatened the plant with potential and damaging down time.

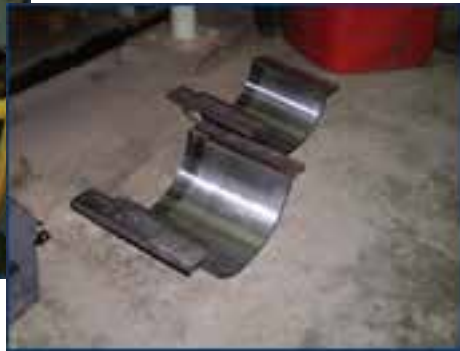
Split Former

Formers were manufactured to original drawing specifications, and the shaft grit blasted using aluminium oxide. Two coats of Belzona® 9411 were applied then only 40 minutes later Belzona® 1121 was applied and the former placed around the repair. Just 24 hours later the shaft was cured and ready for operation again.

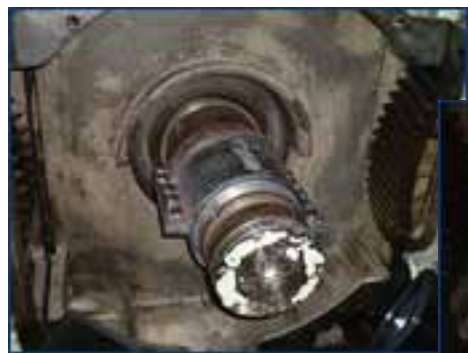
Belzona applied and Former in place

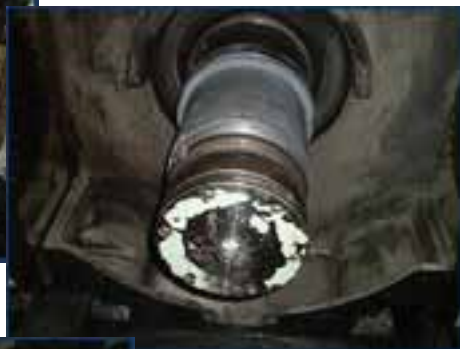
Former Mould Removed

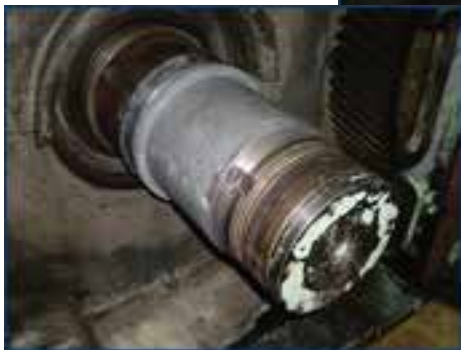
COMPLETED JOB

This type of repair using a former enables a perfect rebuild, which impressed the mill.
