CASE FILE

Helping save precious water with Belzona® 1111!

Desalination Plant, Western Australia, AUSTRALIA

High pressure valve baskets

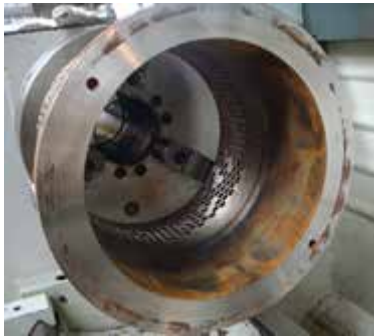
Corroded valve basket

High pressure valves constructed of exotic Monel suffered from crevice/galvanic corrosion on the sealing faces under the gasket areas due to contact with a more noble graphite gasket material and efficient electrolyte. Due to the crevice corrosion compromising the sealing areas underneath the gaskets, the HP valves would leak when operating at full pressure of around 70 bar.

The valve baskets were repaired in order to ensure that at least one of the sealing faces had a machined finish. The repair was undertaken as per VPF-01 and VPF-13, but using the machining technique. The valve baskets were pre-machined in order to create a rough surface which promotes adhesion and allows for the minimum 2mm of rebuild per face. Belzona® 1111 was mixed and applied to the substrate by short bristled brush before being contoured using a pre-cut plastic template. Once cured, the oversized repair was machined to the correct dimensions. The pre-existing bolt holes were re-cast using Belzona® 9411 so as to negate the need for any further drilling and tapping.

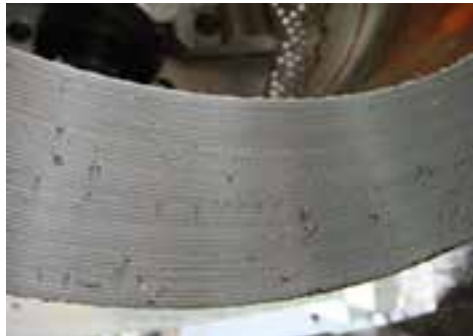
Pre-machined surface

A Monel steel which was machined to produce a very rough finish with burrs.

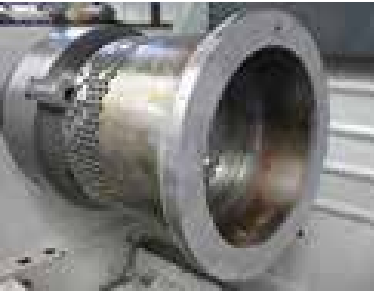
Post-machined basket

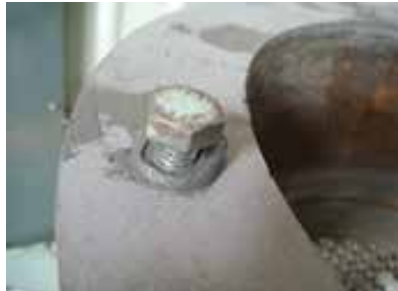
Casting of the bolt holes

Belzona applied to the basket
