CASE FILE

CONTAINMENT WAS PARAMOUNT! Turbine Condenser Repair Made Easy...

Sugar Mill, Queensland, AUSTRALIA

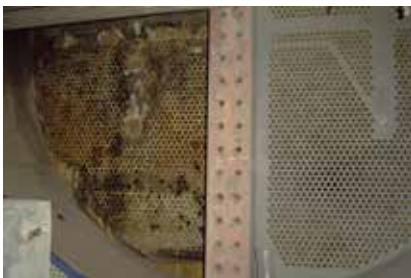
Half Blasted

Blasting was completed using Sponge-Jet. This enabled dust and media to be contained relatively easily.

Chloride levels were checked, and found to be very low following the blasting process - (<7PPM).

Typically the profile achieved was around 120 micron.

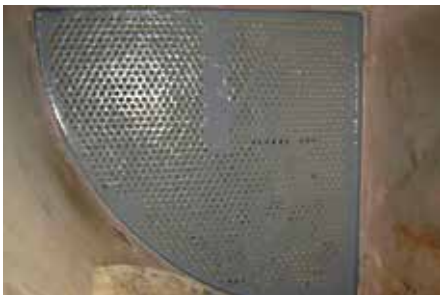
Coated Quarter

Entire face was stippled with Belzona 1391 by brush. This ensured minimal amount of coating entered into each tube. Once complete, a new brush was used to smooth the face out. A second coat was then added, within 30 minutes of the first coat being applied, using the same method. Once cured, each hole was ground with a die grinder, to center, and then drilled to remove unwanted coating.

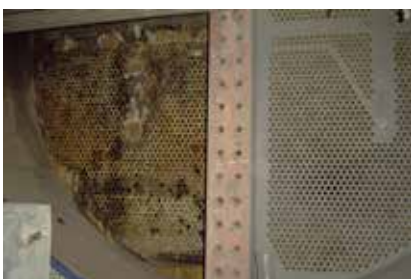
Half Coated

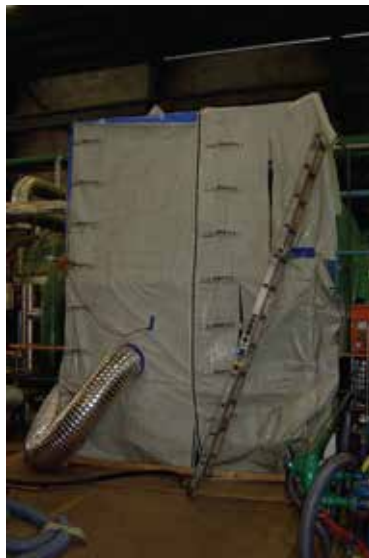
Containment
for Sponge-Jet
blasting

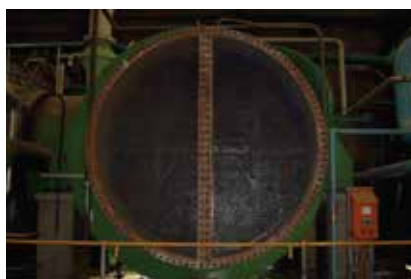
Finished End
