CASE FILE

Geared Up for Good Vibrations!

Large Paper Mill, New South Wales, AUSTRALIA

This gearbox required refurbishment and correct adjustments and alignments.

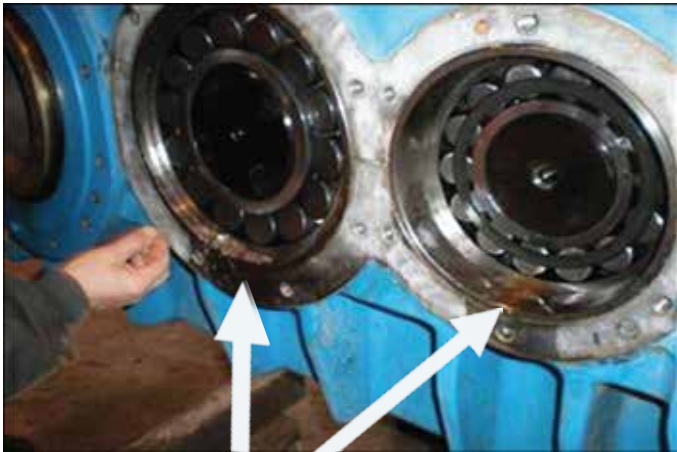
Metal shavings from incorrect bearing contact.

The gearbox suffered from incorrect gear mesh and gear float settings. As a result, this caused indentation in the gear teeth and excessive loads on gears and bearings, causing premature wear and subsequent unwanted vibrations and fine metal bearing material evident, leading to contamination of lubricating oil, bearings and gears.

The first step was to check all shafts for straightness on the centre lathe. All journals of the shaft and gear teeth were then polished to remove any high spots and sharp edges. Bearings were then installed on the shaft using the bearing induction heater to heat the bearings. The top cover was then installed with sealing glue in between the flanges. The axial thrust was checked again before being fully re-assembled, cleaned and painted. The lubricating system was cleaned with high pressure air, the VEM electric motor was replaced and the oil filter and O rings of the pipe work were also replaced.

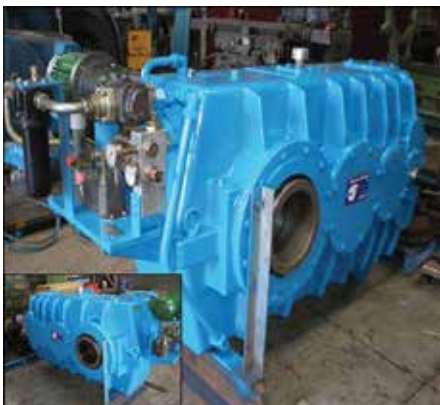
Correctly refurbished to prevent costly breakdowns and plant shutdowns.

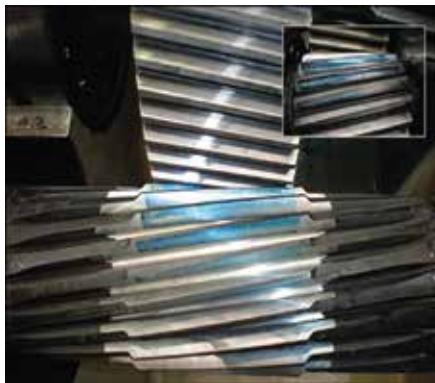
Fully refurbished, cleaned and coated.
