CASE FILE

Operation Neutralize with Belzona® Magma Quartz!

Power Station, Nanango, Queensland, AUSTRALIA

Badly damaged bund and plinth areas.

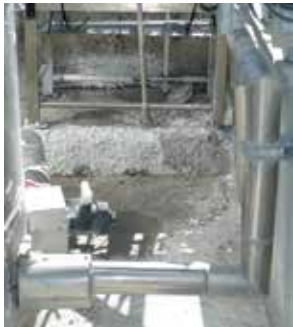
A badly degraded plinth.

The damage had also affected the walls.

Caustic residue had to be removed and neutralized before any rebuild works could begin.

The first step was to remove all deteriorated concrete. The entire bund and plinth area was then high pressure water blasted to remove crystallized caustic residue. Diluted Hydrochloric Acid was then broomed around the bund and plinths to neutralize any active caustic soda. The entire bund and plinth areas were rinsed and allowed to dry overnight. The next morning re-profiling work began by treating the concrete with Magma TX Conditioner to seal the concrete and enhance the adhesion of the Magma Quartz. The Magma Quartz was applied and allowed to cure for 5 hours before receiving it's first coat of Belzona® 5811 Immersion Grade, which was left to cure overnight. The final coat of Belzona® 5811 was applied the following day and reached full chemical resistance just five days later.

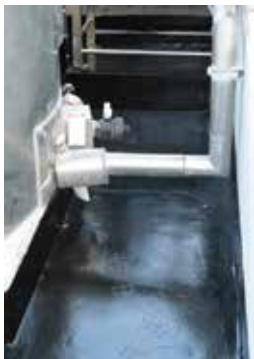
First coat of Belzona® 5811 (black colour).

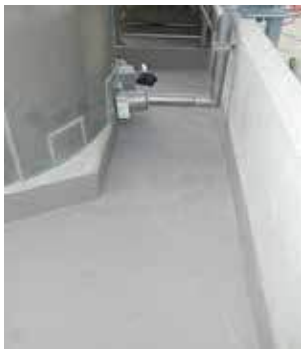
Bund area re-profiled with Belzona® Magma Quartz.

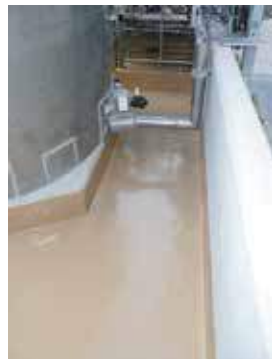
Bund area receives final coat.

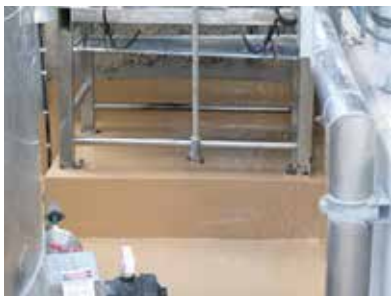
Belzona® 5811 reaches full chemical resistance after just 5 days cure time.
