CASE FILE

Keeping the wheel turning with Belzona® Magma Quartz!

Water Treatment Plant, Brisbane, Queensland, AUSTRALIA

Damaged areas of the concrete rim of the clarifier.

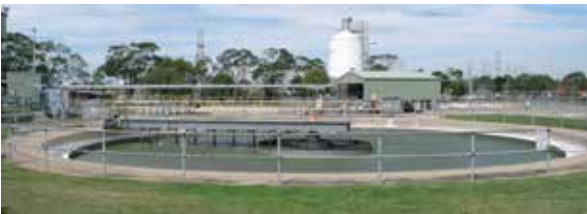
The polyurethane tyre peeled off the solid steel rim of the clarifier wheel and caused damage to three areas of the concrete. This clarifier operates 24 hours a day, seven days a week, therefore any maintenance works must be undertaken in a minimum of downtime.

The damaged area was only shallow, so it was important to utilise a suitable product. This is where Belzona® Magma Quartz was the superior choice as it will work in profiles as little as 6mm with a compressive strength of 914kgs/cm²... that's a whopping 13,000 psi!

The first step was to remove the pieces of broken concrete and then the area was "faced" to remove any contaminants. The areas to be repaired were also brushed down to remove any dust. The next step was to apply Belzona® TX Conditioner to help seal the concrete and enhance the Magma Quartz adhesion. The TX Conditioner was allowed to tack off while the Belzona® Magma Quartz product was prepared. The final step was to smooth out the repair areas.
