## CASE FILE

### Protecting assets in high rise buildings with Belzona® products!

Various areas and repair sites throughout high rise buildings such as plant room floors, air conditioning chillers and leaking roofs.

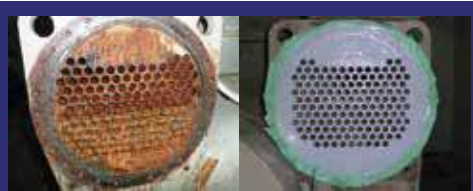
Air conditioning chiller before & after...  
What a transformation!

Air conditioning chillers struggle to meet output demands during hot summer days. Blocked tubes, rust in the system, difficulties in water balance are all common problems.

Each situation varies in application method requirements. In all instances, the substrates are methodically prepared to ensure maximum bonding of the product. Preparation can include grit blasting, high pressure water cleaning and conditioning with Belzona product. Under controlled conditions, the appropriate product is applied and allowed to cure for the required time before going back into operation.

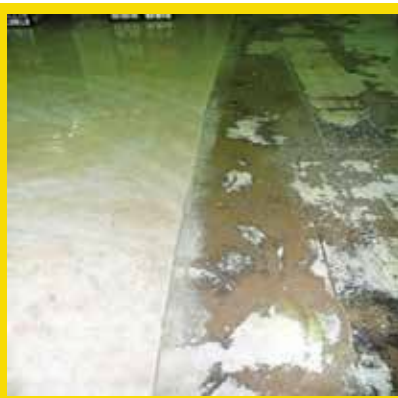
After ▲ Concrete floor ▲ Before

Concrete is vulnerable to attack from abrasion, impact, vibration and chemicals. Because of its porous nature and the weak electronic forces which hold the individual cement crystals together all concrete deteriorates. Such are the problems for plant room floors, stairs, ramps, cool room floors and roofs of high rise buildings.

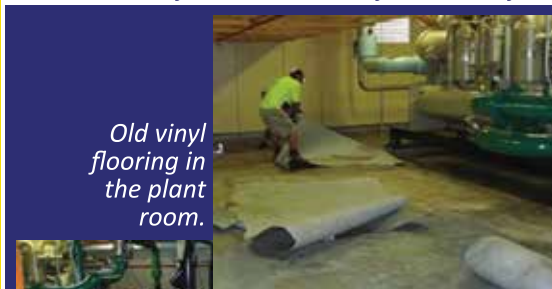
Old vinyl  
flooring in  
the plant  
room.

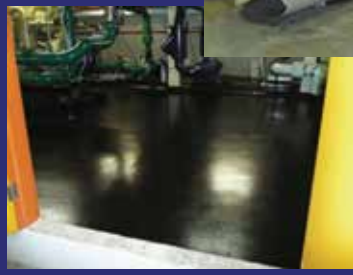
The revived  
plant room  
floor.
