# BEARING FAILURES

Failure to the drive bearing  
in a 12,000 CFM Liquid  
Ring Vacuum Pump in the  
North Queensland Mining  
Industry.

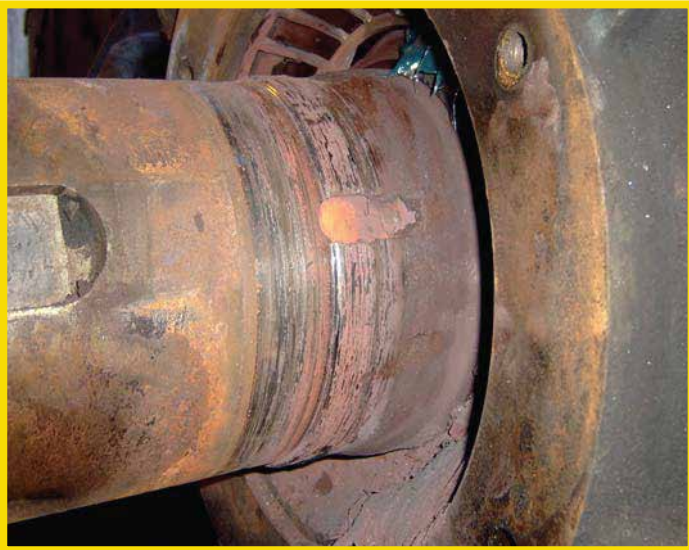
*This unit, while not running,  
has estimated down time  
costs of A\$120,000 per day*

1. Remove unit and replace the shaft (1-2 weeks);
2. Repair the damaged shaft in position using Belzona and Forming Technique.

Needless to say Option 2 was taken, and the shaft was repaired over a 36 hour period.

This included the manufacturing of the specialised former. No machining of the shaft was required due to the zero shrinkage capabilities of the Belzona products.
